2014 Pigeon Creek Watershed Management Plan

Steuben, LaGrange, DeKalb & Noble Counties
Indiana

Prepared By: Northwater Consulting

Prepared For: Steuben County Soil
and Water
Conservation District

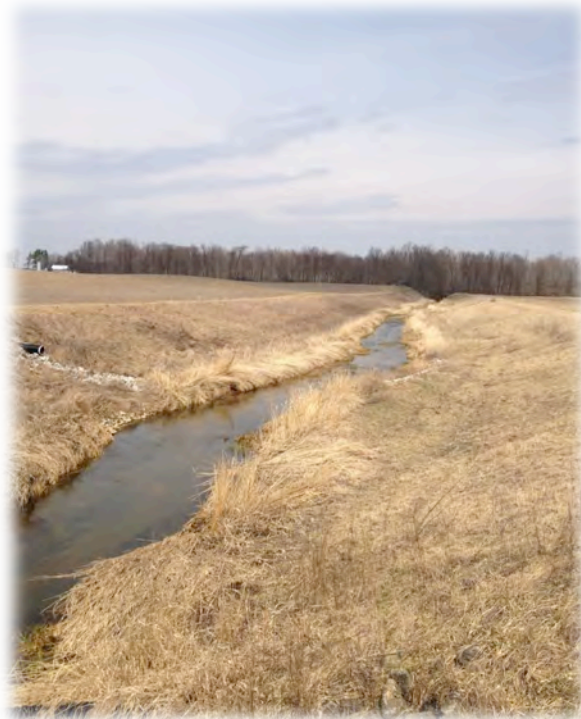
Two-Stage Ditch; Pigeon Creek Watershed

One of the plan's best management practices, for example, is the two-stage ditch that benefits both agriculture and the environment. The design of the two-stage ditch mirrors the natural processes of stable streams to reduce erosion, sediment and nutrients runoff, and flooding that conventional ditches can cause. The floodplain that runs alongside the ditch allows the water to have more area to spread out. This decreases the velocity of the flow while increasing the volume of water the ditch can process - improving drainage, water quality, and habitat and agricultural conditions.

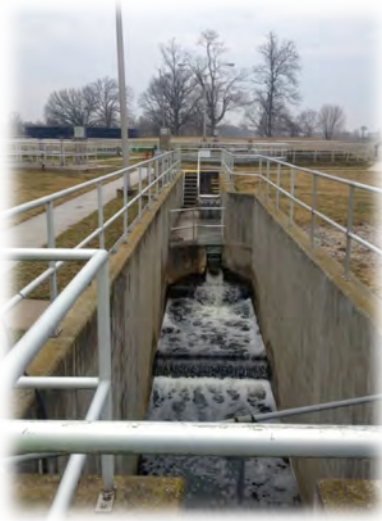
Angola Waste Water Treatment Plant

Angola operates a Class III conventional activated sludge treatment facility. The capacity is 1.7 Million Gallons per Day (MGD). The facility consists of a bar screen, degritter, two (2) flow equalization basins, three (3) primary clarifiers, three (3) aeration tanks, three (3) secondary clarifiers, ultraviolet light disinfection and an effluent flow meter. Class B biosolids are aerobically digested and belt filter pressed, stored, and land-applied by a licensed hauler. The collection system is comprised of combined sanitary and storm sewers with two (2) CSO locations. The CSO locations have been identified and are permitted. The long-term plan is to minimize/eliminate these two CSO discharges through sewer separation projects and removal of illicit connections

The facility discharges to Outfall 001, which is located at latitude: 41° 37' 38" N, Longitude: 84° 58' 59" W. The receiving water is Wood Ditch, which empties to Mud Creek and, eventually, Pigeon Creek. The CSOs also discharge to Wood Ditch.

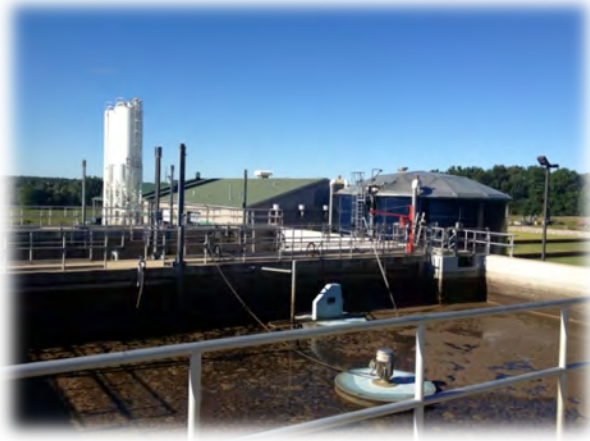
Steuben Lakes Waste Water Treatment Plant

The Steuben Lakes Regional Waste District currently operates a Class III, 1.0 MGD treatment facility consisting of three sequencing batch reactors (SBR), a two-day polishing pond, cascade aeration, and an ultraviolet light disinfection unit. Solids handling includes a sludge holding tank, a two-day polishing pond, an alkaline treatment system, and a sludge storage pad. The supernatant from the sludge storage tank is pumped back to the headworks of the plant.

The collection system is comprised of 100% separate sanitary sewers by design with no overflow points.

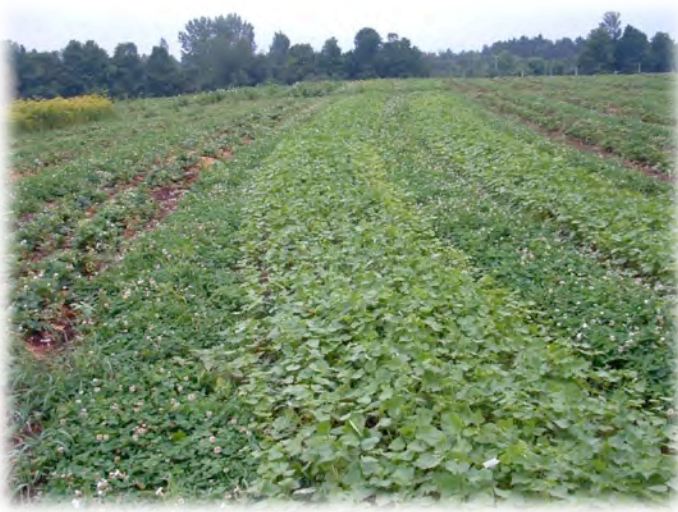
9.1.1 - Cover Crops

Cover Crops are recommended on 39,186 (29%) acres throughout the watershed. Areas targeted for cover crops include primarily flat to gently sloping crop ground. Table 69 lists acreage and load reductions by subwatershed and Figure 53 shows the distribution throughout the watershed. The implementation of cover crops in the watershed will achieve significant reductions in phosphorus (0.7 lbs/ac/yr), nitrogen (3.9 lbs/ac/yr), and sediment (0.7 tons/ac/yr) and, to a lesser extent, bacteria (0.57 billion CFU/ac/yr). Implementation should be

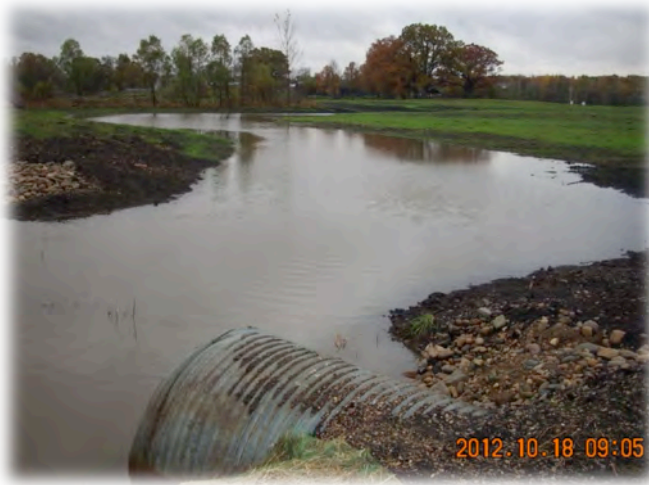
9.1.4 – Wetland Restoration

Wetland restoration is recommended on 12,054 acres (9%) throughout the watershed. Wetland restoration sites include existing and degraded wetlands; restoring these sites will improve filtering, storage capacity, and habitat diversity. Restoration actions can include sediment removal and minor excavation, installing buffer strips around wetlands, the removal of drain tiles and native vegetation planting. Table 72 lists acreage and load reductions by subwatershed and Figure 56 shows the distribution throughout the watershed.

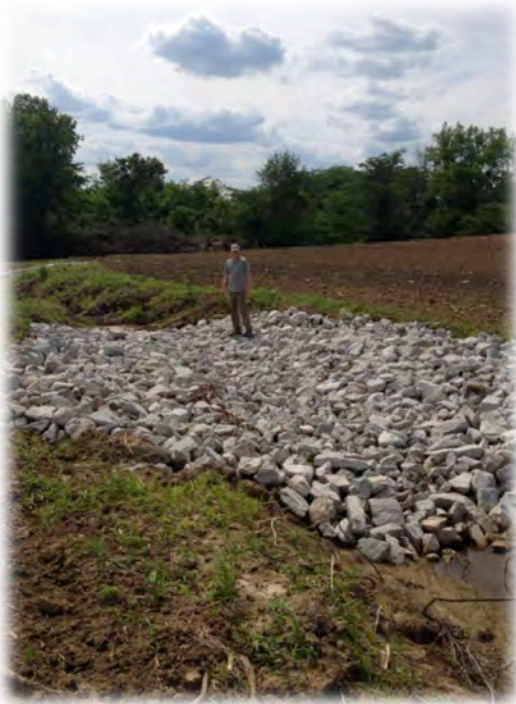
9.2.5 - Rock Riffle

One (1) site-specific riffle (R1) is recommended in the watershed. If implemented, this practice will benefit 42 acres and will reduce phosphorus loads by 29 lbs/yr, nitrogen loads by 127 lbs/yr, bacteria loads by 13 billion CFU/yr, and sediment by 38 tons/yr. Priority should be given to this site as it is within a critical subwatershed (highlighted red in Table 81). Figure 69 shows the location of this practice in the watershed.

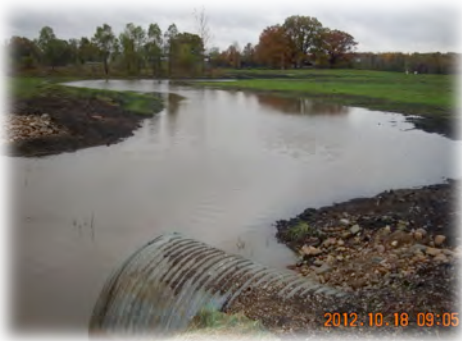
1) J. Leach Wetland: work began on this 2.66-acre wetland project September 7th, 2012, and was completed October 15th, 2012. This large restoration project included a wetland detention area with an outlet structure. The goal of this project was to restore a wetland habitat in the Pigeon Creek watershed. Located on the property of the Angola Parks Department, the J. Leach Wetland is storing and filtering urban stormwater runoff, as well as improving local wildlife habitat.

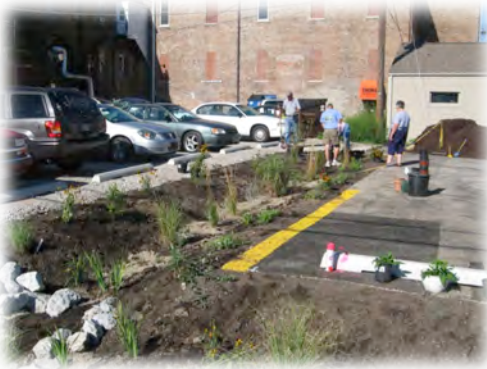
2) Rain Garden, City of Angola: numerous green infrastructure BMPs have been installed within the City of Angola, including rain barrels, pervious/porous pavement, and riparian buffers. This rain garden, located in downtown Angola, is trapping and filtering roof and pavement runoff. Future plans include additional rain gardens and urban green infrastructure BMPs.

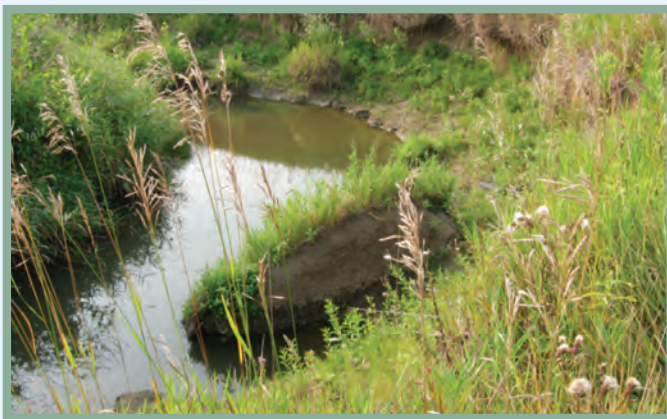
Figure 1. A: A trapezoidal ditch in Indiana with bank erosion and mass bank failures.

The objective of this fact sheet is to provide guidelines for the tri-state region (Indiana, Michigan, Ohio) on determining the geometry of a two-stage ditch system based on the size of the upstream drainage area. In the region, agricultural drainage ditches serve as outlets for subsurface drainage systems. They traditionally are designed with a trapezoidal cross-section to move water downstream efficiently. In comparison to streams that have connected and active floodplains, trapezoidal ditches lack floodplains and as a result often experience bank erosion or excessive accumulation of sediments (Figure 1A). An improvement on the traditional trapezoidal ditch design is a two-stage channel system that is designed to take advantage of the benefits of active floodplains¹. These systems are more self-sustaining as they work in harmony with fluvial processes so that sediment transport is in balance (Figure 1B).

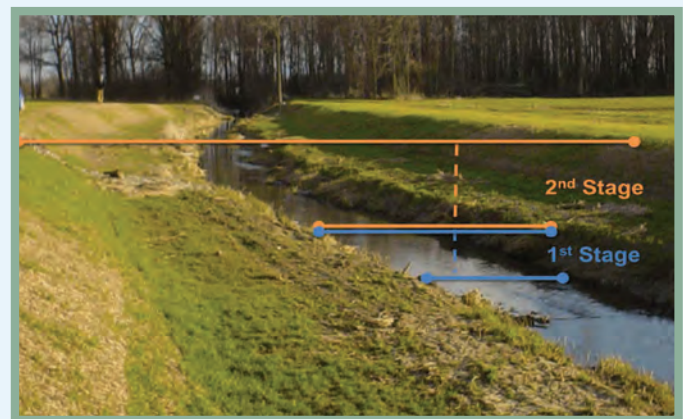
Figure 1. B: A two-stage ditch in Michigan.

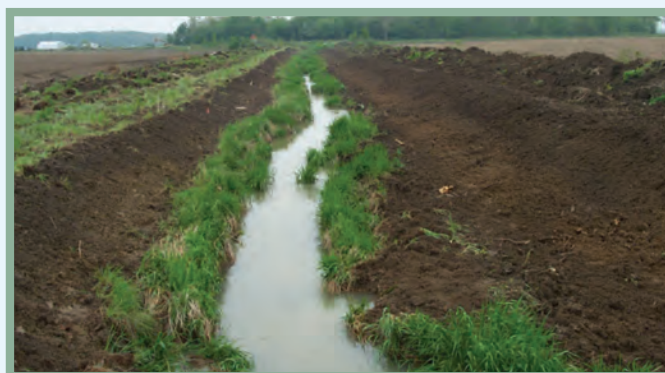
Figure 3. B: Modification of a ditch to a two-stage geometry by pulling the banks back to form benches.

Example: A ditch with a 3.5 mi² drainage area has a measured inset channel width of 12 ft and existing 3-4 ft wide benches about 1.7 ft above the bottom of the ditch. If a two-stage ditch will solve an existing problem then we would recommend widening the existing benches to give a total flooded width of 36 ft (from Table 1) about 1.7 ft above the bottom of the ditch. Figure 3.A shows the original geometry (dashed line), the excavated material (shaded areas), the design geometry (solid line), a 8 ft bench to the left of the inset channel, and a 16 ft bench to the right of the inset channel (corresponds to 24 ft of benches in Table 1 for a 3:1 ratio). Figure 3.B show the two-stage construction concept that does not modify the inset channel, leaves the grass fringe along the inset channel, and pulls back the banks to establish benches.
