#### **Cobus Creek Watershed Diagnostic Study**

#### **Preliminary Findings Public Meeting**

#### **Meeting Summary**

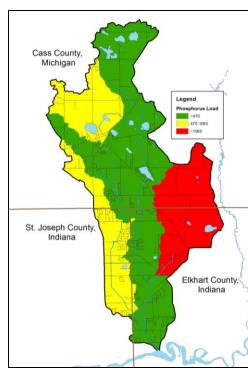
Figure A: Cobus Creek Watershed – implementing projects in the red/yellow areas would greatly improve the overall health of the watershed

- Cobus Creek is a fairly healthy stream, but has flashy pollutant tendencies
- Highest loading of pollutants in the watershed occurs at tributaries draining into Cobus Creek (Cobus Creek East Lateral A, Gast Dtich, inlet to Spring Lake)
  - Focusing improvement projects in these regions would likely show the biggest improvement in water quality in Cobus Creek
- Implementing best management practices (BMPs) to reduce phosphorus concentrations would be an ideal priority
  - Septic system maintenance
  - Rain barrel/rain garden installs
  - Stream bank stabilization
- Implementing BMPs that focus on stormwater retention and sediment cover would help with elevated pollutants during storm flow conditions
  - Agricultural BMPs cover crops, conservation tillage, filter strips

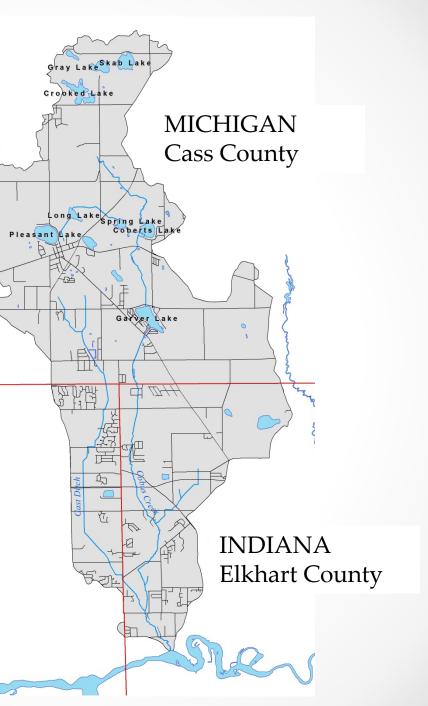
### Cobus Creek Watershed

(23,412 acres)

INDIANA St. Joseph County

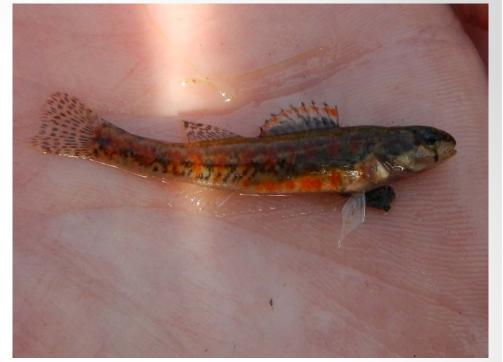
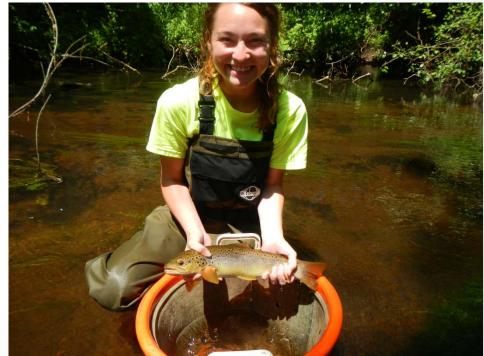
# Community & Habitat Limitations

- Cool-water stream
- Channelization
- Limited pools and riffles
- Limited instream habitat
- Fish migration barriers

- Channelization and modification of natural stream conditions
  - Limited pools and riffles highly quality habitat
  - Several barriers (low-head dams and road stream crossings) for fish migration exist along Cobus Creek
