Cobus Creek Watershed Diagnostic Study

Steering Committee Recap

June 28, 2016 - 2:30pm

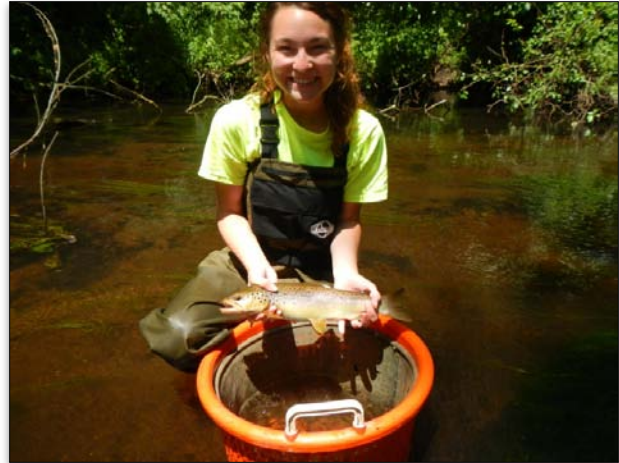
Figure 3: Brown Trout found in Cobus Creek at County Road 12 in Elkhart County

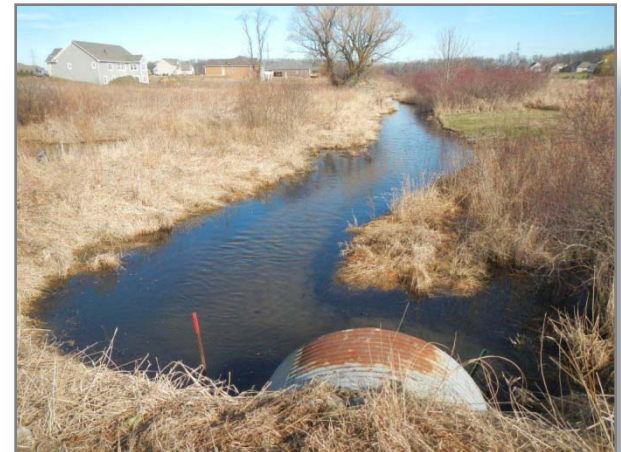
- Gast Ditch & Cobus east lateral have significantly impaired fish communities
- Biggest limitation for fish is habitat degradation
 - ▣ Channelized segments of Cobus
 - ▣ Dams and perched culverts fragmenting fish communities

Perched culvert on Cobus @ CR 2

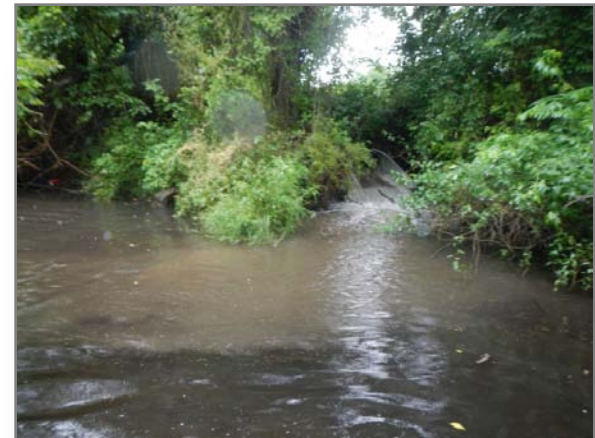
Storm drain discharging to Cobus Creek
