**COBUS CREEK WATERSHED DIAGNOSTIC STUDY**

**ELKHART AND ST. JOSEPH COUNTIES, INDIANA AND CASS COUNTY, MICHIGAN**

**28 MARCH 2017**

## CREEK WATERSHED DIAGNOSTIC STUDY EXECUTIVE SUMMARY

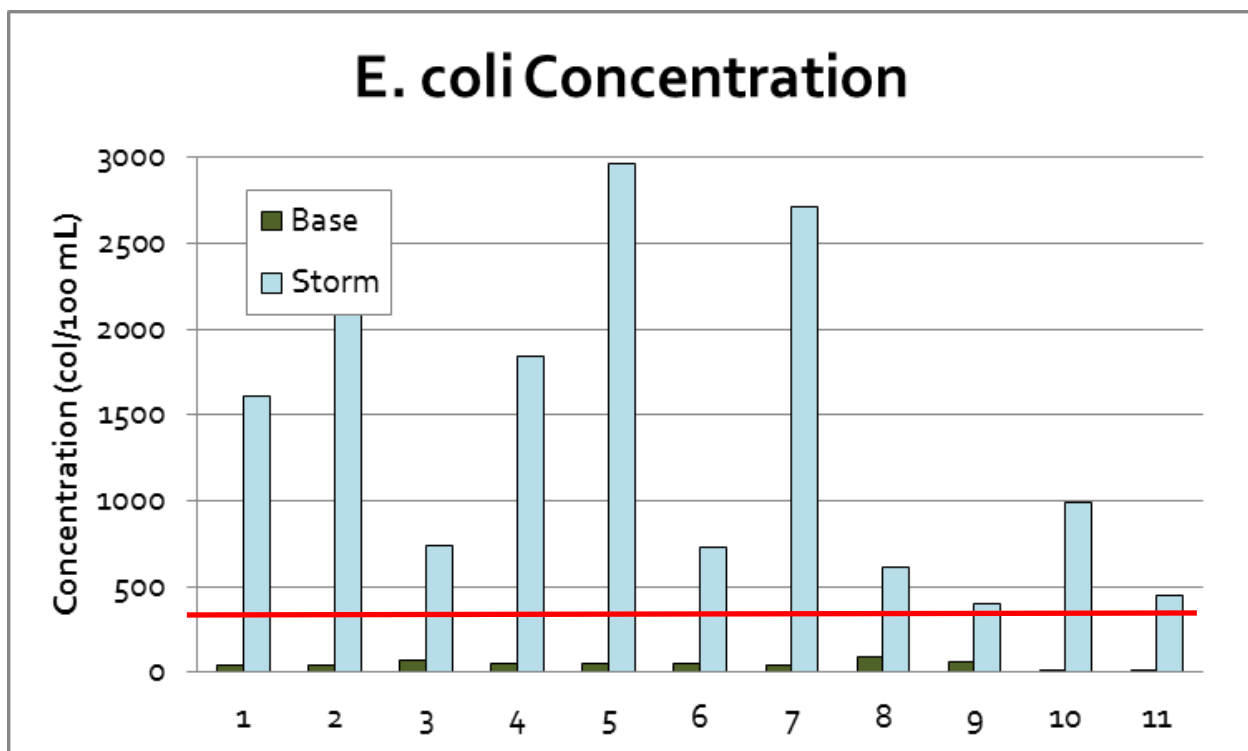
*E. coli*: Figure 23 displays the *E. coli* concentration data for Cobus Creek Watershed streams. *E. coli* concentrations exceeded the Indiana state standard (235 colonies/100 ml) for state waters at all sites under storm flow conditions, but measured below the state standard during base flow at all sites. The Spring Lake inlet (Site 10) contained the lowest *E. coli* concentrations under base flow conditions, measuring 1 col/100 mL. Under storm flow conditions, the Garver Lake inlet (Site 9) contained the lowest *E. coli* concentration (398 col/100 mL) which measured 1.5 times the state standard. Storm flow concentrations measured at the Gast Ditch at Adams Road (Site 5) measured the highest with concentrations approximately 12 times the state standard (2960 col/100 mL). These pathogens may impair the biota in the Cobus Creek Watershed and limit human use of the streams. The precise sources of *E. coli* in the Cobus Creek Watershed have not been identified; however, wildlife, livestock, and/or domestic animal defecation; manure-based fertilizers; previously contaminated sediments; and failing or improperly sited septic systems are common sources of the bacteria in this region.

Figure 23. *E. coli* concentration measurements during base and storm flow sampling of Cobus Creek Watershed streams. The red line indicates the target concentration (235 col/mL; IAC).

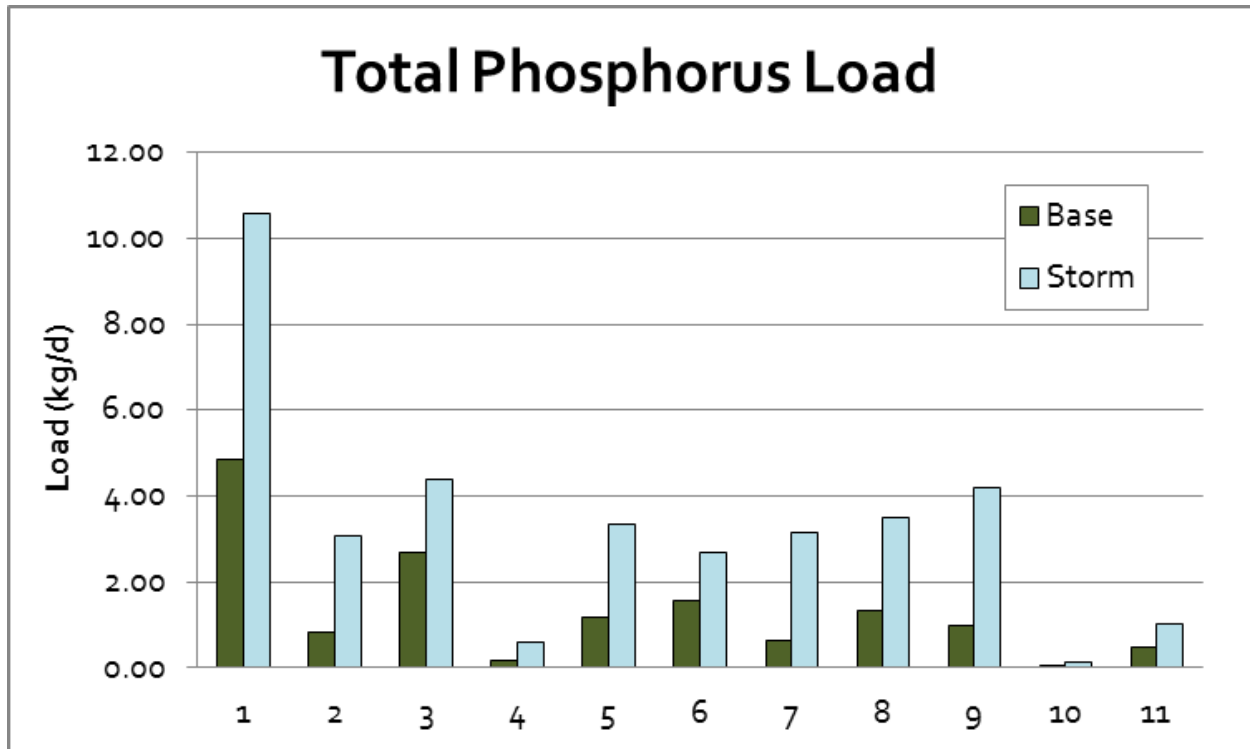
Figure 28. Total phosphorus loading rates measured during base and storm flow sampling of Cobus Creek Watershed streams.

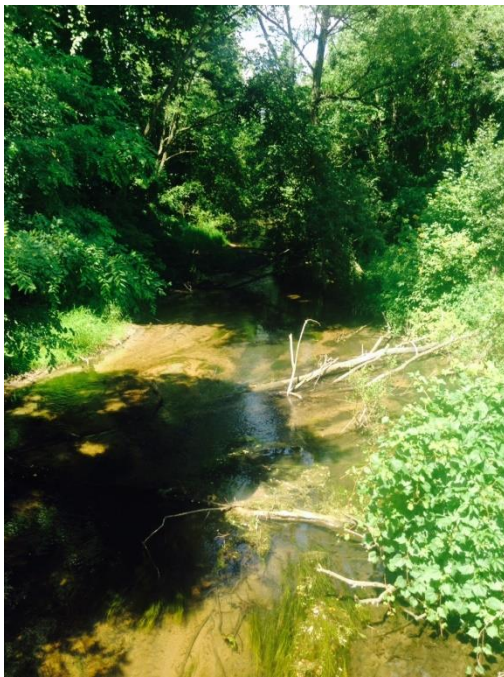
*Cobus Creek at County Road 2 (Site 1)*: The QHEI score average 65.8 out of a possible 100 points, the second highest habitat score of sites within the Cobus Creek Watershed. Substrate composition at this site was predominately cobble and gravel with some sand, muck/silt, and detritus. Silt cover was normal, while substrate embeddedness was low. Instream conditions were good with low substrate embeddedness, good pool depth early in the season, and limited riffle/run development. Overhanging vegetation, aquatic macrophytes, woody debris, boulders, shallows in slow water, undercut banks, and rootwads provided good instream cover (Figure 33). The site was surrounded by forest on one side and open pasture or row crop on the other. The riparian zone measured narrow to moderate up to 164.5 feet (50 meters) from either streambank. Bank stability was good with little to no erosion present. No sinuosity was observed in the stream reach with recent to no recovery from channelization. The mIBI score for this site was 22 scoring 52% of the reference site on Christiana Creek indicating that the stream is "moderately impaired." The moderately tolerant mayfly *Baetis hageni* dominated the macroinvertebrate community. A high EPT: Chironomid ratio, a high modified HBI score, low numbers of EPT species and low numbers of scrapers and collectors generate the moderate mIBI score. Cobus Creek at CR 2 scored the highest coolwater IBI score rating 40, or good, during both the spring and summer assessments. Blacknose dace dominated the fish community during both assessments.

**Figure 33. Site 1 sampling location on Cobus Creek.**

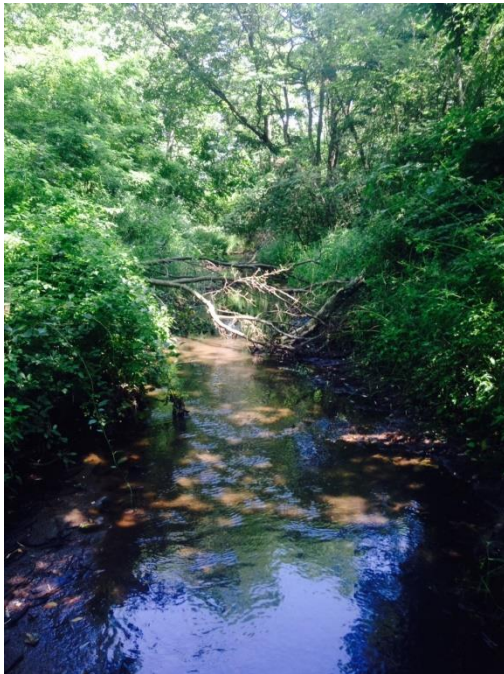
Figure 34. Site 2 sampling location on Gast Ditch.

*Gast Ditch at County Road 8 (macroinvertebrates) and Douglas Road (fish; Site 2):* This site received a QHEI score of 36.8 of a possible 100, the second lowest of all sites assessed. The substrate composition at the site was a combination of sand and gravel. Substrate embeddedness was moderate. Shallows in slow water, rootmats, and logs or woody debris, provided sparse levels of instream cover. Low sinuosity was present with evidence of recent recovery from channelization (Figure 34). The riparian zone extended between 16.2 and 32.4 feet (5 to 10 meters) on either side of the streambank. Shrubs or old field dominated the riparian vegetation. Both stream banks were moderately eroded. Pool/ riffle development was fair with the presence of moderately deep pools, which possessed slow flows. The mIBI score was 8 rating 19% of reference site score on Christiana Creek, which is indicative of the “moderately impaired” condition at this site. The most abundant macroinvertebrates at this site were the moderately tolerant *Gammarus pseudolimnaeus*, accounting for 91% of the macroinvertebrate community present in this reach of Gast Ditch. A low number of taxa, low number of EPT taxa, high dominance by one species, low numbers of scrapers and collectors, low percent shredders, and a low community loss index characterized the macroinvertebrate community at this site. IBI scores also rated poorly at this reach scoring 7 and 9, respectively, or very poor during the spring and summer assessments. Only two individuals, one bluegill and one golden shiner, were found during the spring assessment and fifteen individuals from one species, creek chub, were found during the summer assessment. Gast Ditch at Douglas Road was nearly dry during the July 27 assessment. These data suggest that habitat likely limits the biological community present in Gast Ditch at County Road 2.

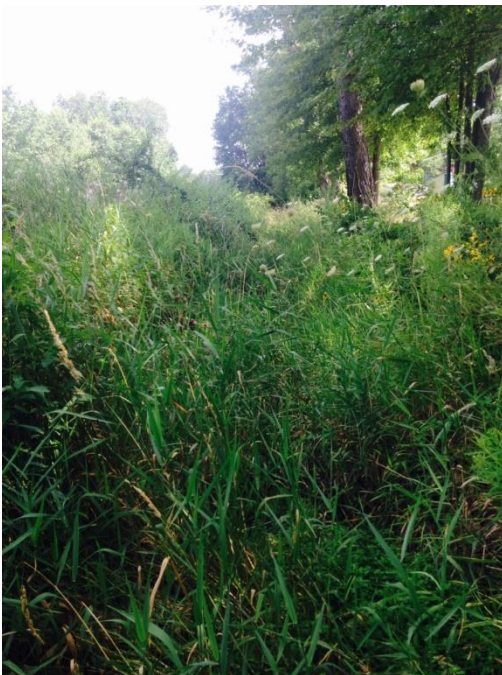
Figure 36. Site 4 sampling location on the Cobus East Lateral A.

*Cobus East Lateral A (Site 4)*: The Cobus East Lateral A received a QHEI score of 27.3, the lowest of any sites assessed in the Cobus Creek Watershed. Silt and muck dominated the substrate. The substrate was extensively embedded with heavy levels of silt cover. Instream cover present in moderate levels in early June with overhanging vegetation, shallows in slow water, deep pools, aquatic macrophytes, and logs or woody debris providing moderate cover. However, as water levels dropped throughout the summer, instream cover was nearly absent (*Figure 36*). Moderate bank erosion was present throughout the reach creating low channel stability. Stream sinuosity was absent with no pool/riffle development. The riparian buffer was limited with residential areas adjacent to both banks. Pool/ riffle development was poor; no deep pools were observed at this site, while shallow, gravel and sand riffles predominated. The mIBI score (22) indicated that the macroinvertebrate community was slightly impaired, rating 67% of the reference site's score. A low number of taxa, low community loss index, low modified HBI score, and high EPT: Chironomid ratio, high percent of shredders, and good numbers of scrapers and collectors characterize this site. The dominance of the community by the right handed snail family, *Physidae*, and the absence of members of the *Chironomidae* family generates a relatively good macroinvertebrate community score for the Cobus Creek Watershed. The fish community reflects the poor habitat present at this site scoring 7 and 0, or very poor, respectively during the spring and summer assessments. Seven species were present in relatively low density during the spring assessment, while no fish were observed during the summer assessment.

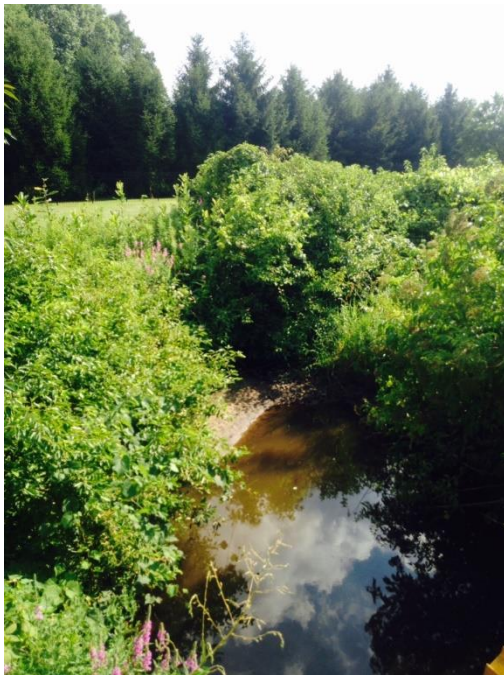
Figure 37. Site 5 sampling location on Gast Ditch.

*Gast Ditch at Adams Road (Site 5)*: This site received a QHEI score of 45.5 out of a possible 100 points. Like other sites along Gast Ditch, habitat quality rated better earlier in the season and as water levels declined, pool/riffle habitat and instream cover accessibility decreased resulting in poorer habitat scores in late July. Sand dominated the substrate at this reach, with gravel present early in the season and muck present later in the summer. In total, sand, gravel, muck, silt, detritus, and artificial substrates were present at this site. Silt levels were normal with normal substrate embeddedness. Overhanging vegetation, shallows in slow water, deep pools, aquatic macrophytes, and logs or woody debris provided moderate levels of instream cover during the June assessment, while only logs or woody debris were present during the late July assessment (Figure 37). Channel sinuosity was low. The stream possessed moderate pool/riffle development during the June assessment and moderate riffles and nearly absent pools during the late July assessment. Narrow riparian zones with residential development extend less than 32.4 feet (10 meters) on both streambanks. The mIBI score indicated that this site was moderately impaired scoring 20, or 48%, of the reference site score. The macroinvertebrate community was comprised of highly intolerant worm, *Oligochaeta*, biting midges, *Paracladopelma loganae*, and the damselfly genus, *Argia*. A relatively high number of taxa, limited dominance by any one species, a good community loss index, and a poor (high) modified HBI score characterize the community in this reach of Gast Ditch. The fish community is similarly limited scoring 28, or fair, during the spring assessment and only 11, or very poor, during the summer assessment. Relatively limited density and diversity of fish characterized this site during both assessments. The limited habitat present as well as declining water levels likely negatively impact the fish community throughout the summer in this reach of Gast Ditch.

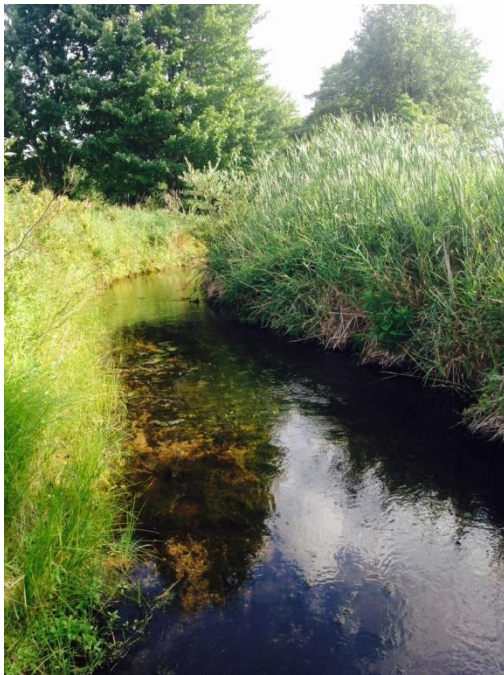
Figure 38. Site 6 sampling location on Cobus Creek.

*Cobus Creek at County Road 2 (Site 6):* Cobus Creek at CR 2 rated an average QHEI score of 52.3 of 100 possible points. Sand and gravel dominated the substrate composition with muck and silt also present. Silt levels were normal with normal substrate embeddedness. Shallows in slow water, rootmats, rootwads, and aquatic macrophytes provided moderate levels of instream cover. Deep pools were present during the June assessment but disappeared as water levels dropped throughout the season. The banks exhibited little to no erosion and this reach was recovered from previous channelization; however, sinuosity of the stream was low. The riparian buffer was very narrow, limited to less than 16.4 feet (5 meters). The vegetation in the riparian zone was predominantly old field or shrubs and residential land uses (Figure 38). Pool/riffle development was fair to poor. The mIBI score was the highest of all sites assessed scoring 44 or 105% of the reference site indicating that the community was slightly impaired. The macroinvertebrate community possessed high taxa richness, high numbers of EPT taxa, relatively low numbers of Chironomids, a good community loss index score, good modified HBI score, and high percent shredders. The macroinvertebrate community was dominated by the beetle, *Stenacron interpunctatum* and the caddisfly genus, *Cheumatopsyche*. Despite the high quality macroinvertebrate community present in this reach of Cobus Creek, the fish community rated as poor scoring 21 during both the spring and summer assessments. Creek chub accounted for more than 80% of the community present during the spring survey and nearly 90% of the community during the summer survey. Sampling during the fish assessments occurred upstream of the road-stream crossing, while sampling during the macroinvertebrate assessment occurred downstream of the road-stream crossing. While the resulting QHEI scores are relatively similar, this could explain the disparity in macroinvertebrate and fish community ratings.

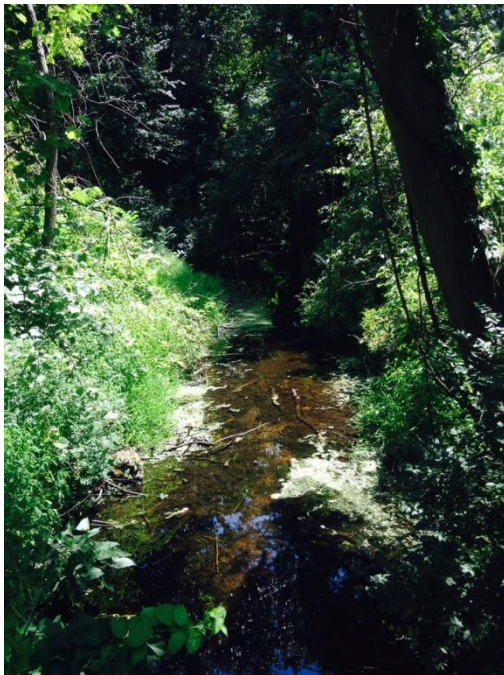
Figure 39. Site 7 sampling location on Gast Ditch.

*Gast Ditch at Redfield Road (Site 7)*: This reach of Gast Ditch scored a QHEI score of 38.8 of a possible 100 points. Substrate composition was a mixture of sand and gravel with the presence of detritus, muck, artificial, and silt substrates also present. The level of substrate embeddedness was moderate with moderate silt cover. Instream cover was sparse to nearly absent containing a mixture of rootmats, boulders, overhanging vegetation, and logs or woody debris (Figure 39). Stream banks showed minimal signs of erosion with low channel stability. The stream reach possessed a low level of sinuosity evidence of recovery from previous channelization. The riparian buffer along both sides of the streambed was moderate extending up to 162.4 feet (50 meters) from the streambanks. The riparian vegetation along the stream consisted of a forest or swamp. Pool/riffle development at the site was minimal with the presence of limited pools and unstable fine gravel or sand riffles. The mIBI score (16) rated as moderately impaired scoring 38% of the reference site's score. The macroinvertebrate community consisted of a moderately diverse group of genera, most of which were moderately tolerant to intolerant to pollution. The predominant macroinvertebrates found at the site were midges, *Paracladopelma loganae*, and worms of the *Oligochaeta* genera. A modest number of taxa, poor EPT diversity, low percent shredders, a poor community loss index, and low EPT: Chironomid index characterize this reach of Gast Ditch. The fish community reflects the limited habitat present in this reach of Gast Ditch and mimic the poor macroinvertebrate community rating 10 and 9, or very poor, during the spring and summer surveys, respectively. Thirteen individuals from three species comprised the spring fish community, while seven individuals representing five species comprised the summer fish community. The community was dominated by non-coolwaters, moderately tolerant species common to wide, ponded stream reaches like Gast Ditch at Redfield Road.

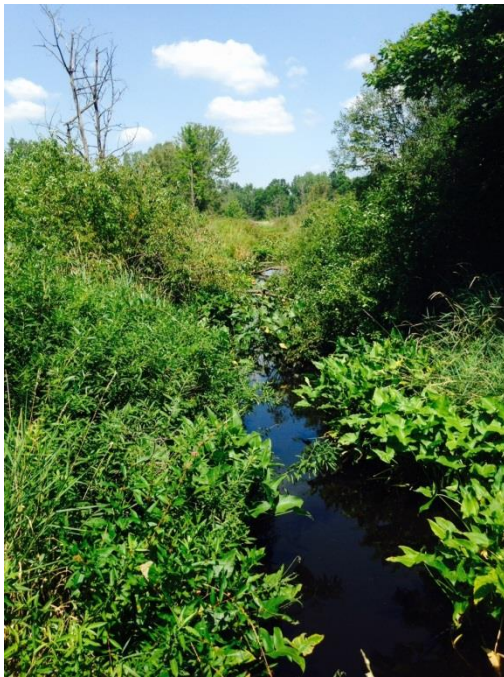
Figure 40. Site 8 sampling location on Cobus Creek.

*Cobus Creek at Redfield Road (Site 8):* The QHEI score for this stream reach averaged 46.7. The substrate composition was a blend of silt, sand, and gravel with a normal level of substrate embeddedness and normal silt levels. The site contained moderate instream cover consisting of shallows in slow water, rootmats, aquatic macrophytes, and logs or woody debris present throughout the reach (Figure 40). Erosion was absent along this reach and the banks were moderately stable. No apparent channelization was observed and the stream channel was relatively straight with low sinuosity. The riparian buffer along each bank was very narrow, extending less than 16.4 feet (five meters) from the streambanks. Pool/ riffle development at the site was moderately poor with limited pool depth and unstable sand and gravel riffles. The macroinvertebrate community rated moderately impaired, scoring 20 or 48% of the reference site score. The macroinvertebrate community was dominated by the amphipod genera *Hyallolella*, which comprised nearly 40% of the community. Low taxa diversity, limited EPT taxa presence, a modest modified HBI score, low number so scrapers and collectors, low community loss index, and low percent shredders characterize the community. The fish community rated good scoring 28 and 27, respectively during the spring and summer assessments. Grass pickerel dominated the community present in this reach of Cobus Creek during both assessments.

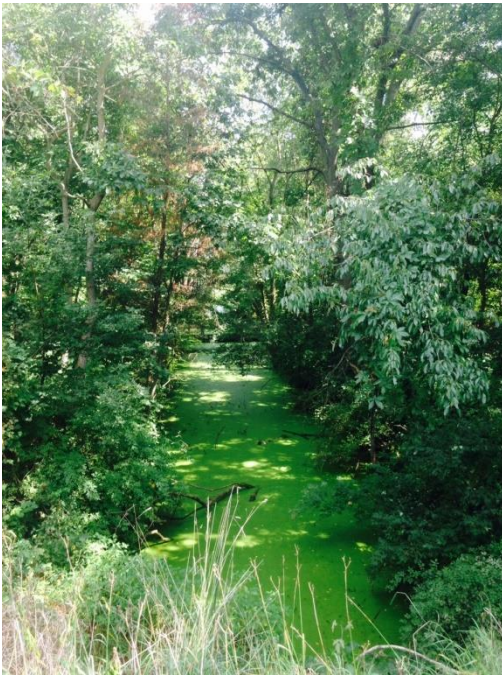
Figure 42. Site 10 sampling location on the Spring Lake Inlet.

*Spring Lake Inlet (Site 10)*: The Spring Lake Inlet scored 52.5 on the QHEI assessment rating the fourth highest of any reaches assessed in the Cobus Creek Watershed (Figure 42). The habitat at this site was only assessed once occurring in concert with the macroinvertebrate community assessment. Muck and silt were the dominant substrate components. The level of substrate embeddedness was heavy, with an extensive amount of silt cover. Instream cover was nearly absent and was comprised of shallows in slow water and logs or woody debris. Erosion along the banks was absent; bank stability was low, with no sinuosity and the signs or recovering from previous channelization. The riparian buffer zone was classified as narrow with widths of 16.2 to 32.4 feet (5 to 10 meters). Pool and riffle development metric scores were low because the reach lacked deep pools and possessed unstable, fine gravel and sand riffles. Despite the relatively high quality habitat present at this site, the macroinvertebrate community was moderately impaired, receiving a mIBI score of 8 or 19% of the reference site score. *Chironomus* species composed nearly 60% of the macroinvertebrate community. Limited taxa diversity, poor numbers of EPT taxa, high number of Chironomids, a poor modified HBI score, high number of shredders, and a poor community loss index score characterize the macroinvertebrate community present at the Spring Lake Inlet. The fish community was not assessed at this site due to accessibility issues.

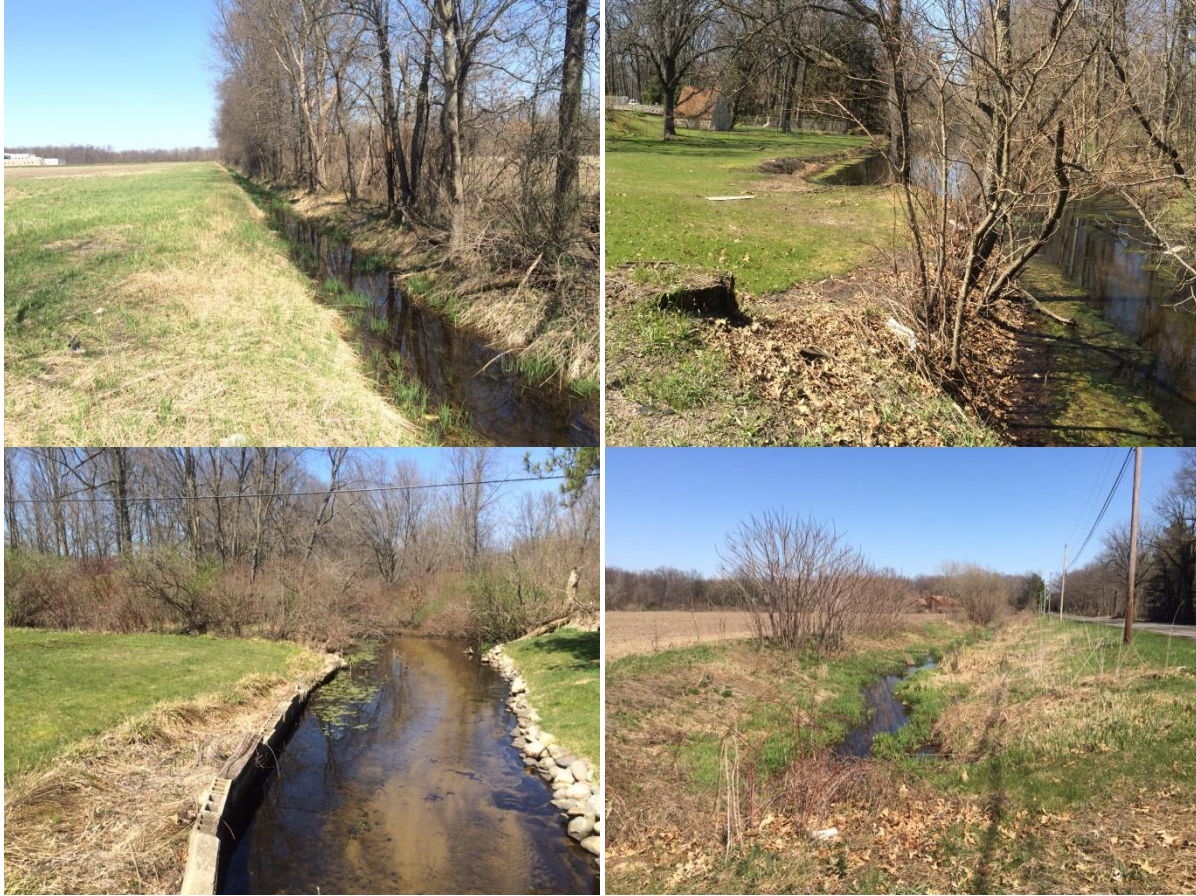
**Figure 55. Areas with narrow buffers observed throughout the Cobus Creek Watershed.**
