## *Pigeon River Watershed Management Plan*

A project for the LaGrange County Soil and Water Conservation District

January 15, 2013

*SNRT, Inc*  
Natural Resource Associates

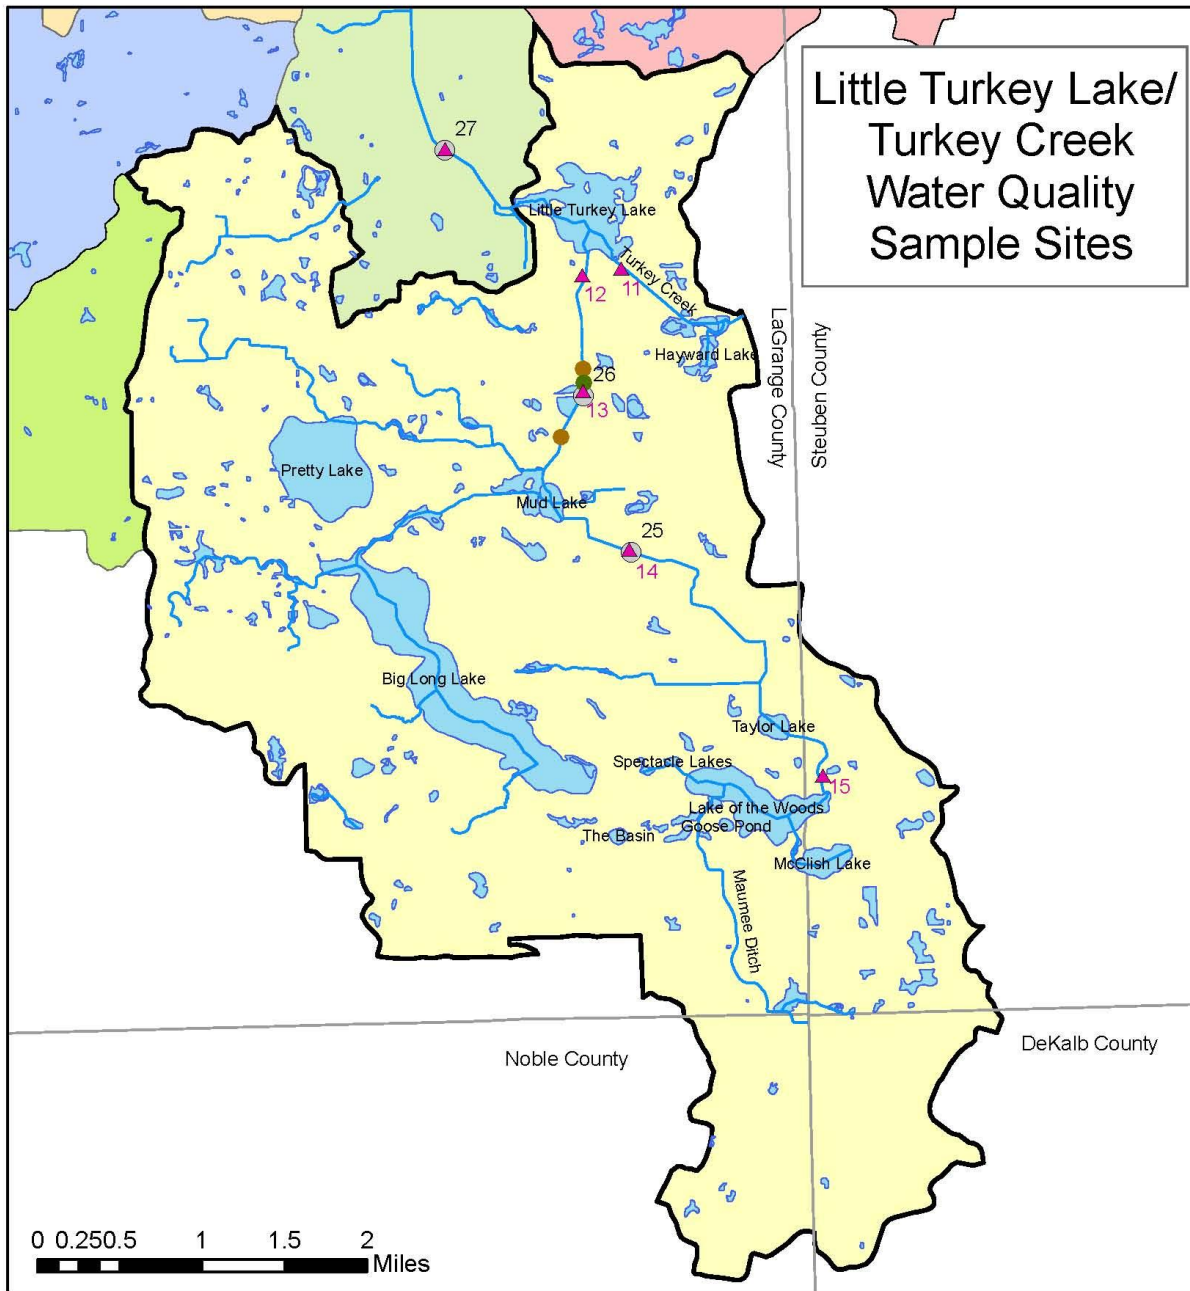
**Figure 16: Little Turkey Lake/Turkey Creek Water Quality Sample Sites**

There are ten total water quality sampling sites located within the Little Turkey Lake/Turkey Creek subwatershed, as can be seen in Figure 16. Two sites were used by IDEM for the 303(d) list; two sites were used by IDEM for the TMDL report; one site was used by IDEM to collect biological data, and five sample sites were used by LaGrange County SWCD to collect water quality data for the purposes of this WMP project.
